SHATTO DAM  
SULLIVAN COUNTY, MISSOURI  
MO 10068

PHASE 1 INSPECTION REPORT  
NATIONAL DAM SAFETY PROGRAM.

PHASE I REPORT  
NATIONAL DAM SAFETY PROGRAM

Name of Dam	Shatto Dam
State Located	Missouri
County Located	Sullivan County
Stream	Tributary to East Locust Creek
Date of Inspection	July 21, 1978

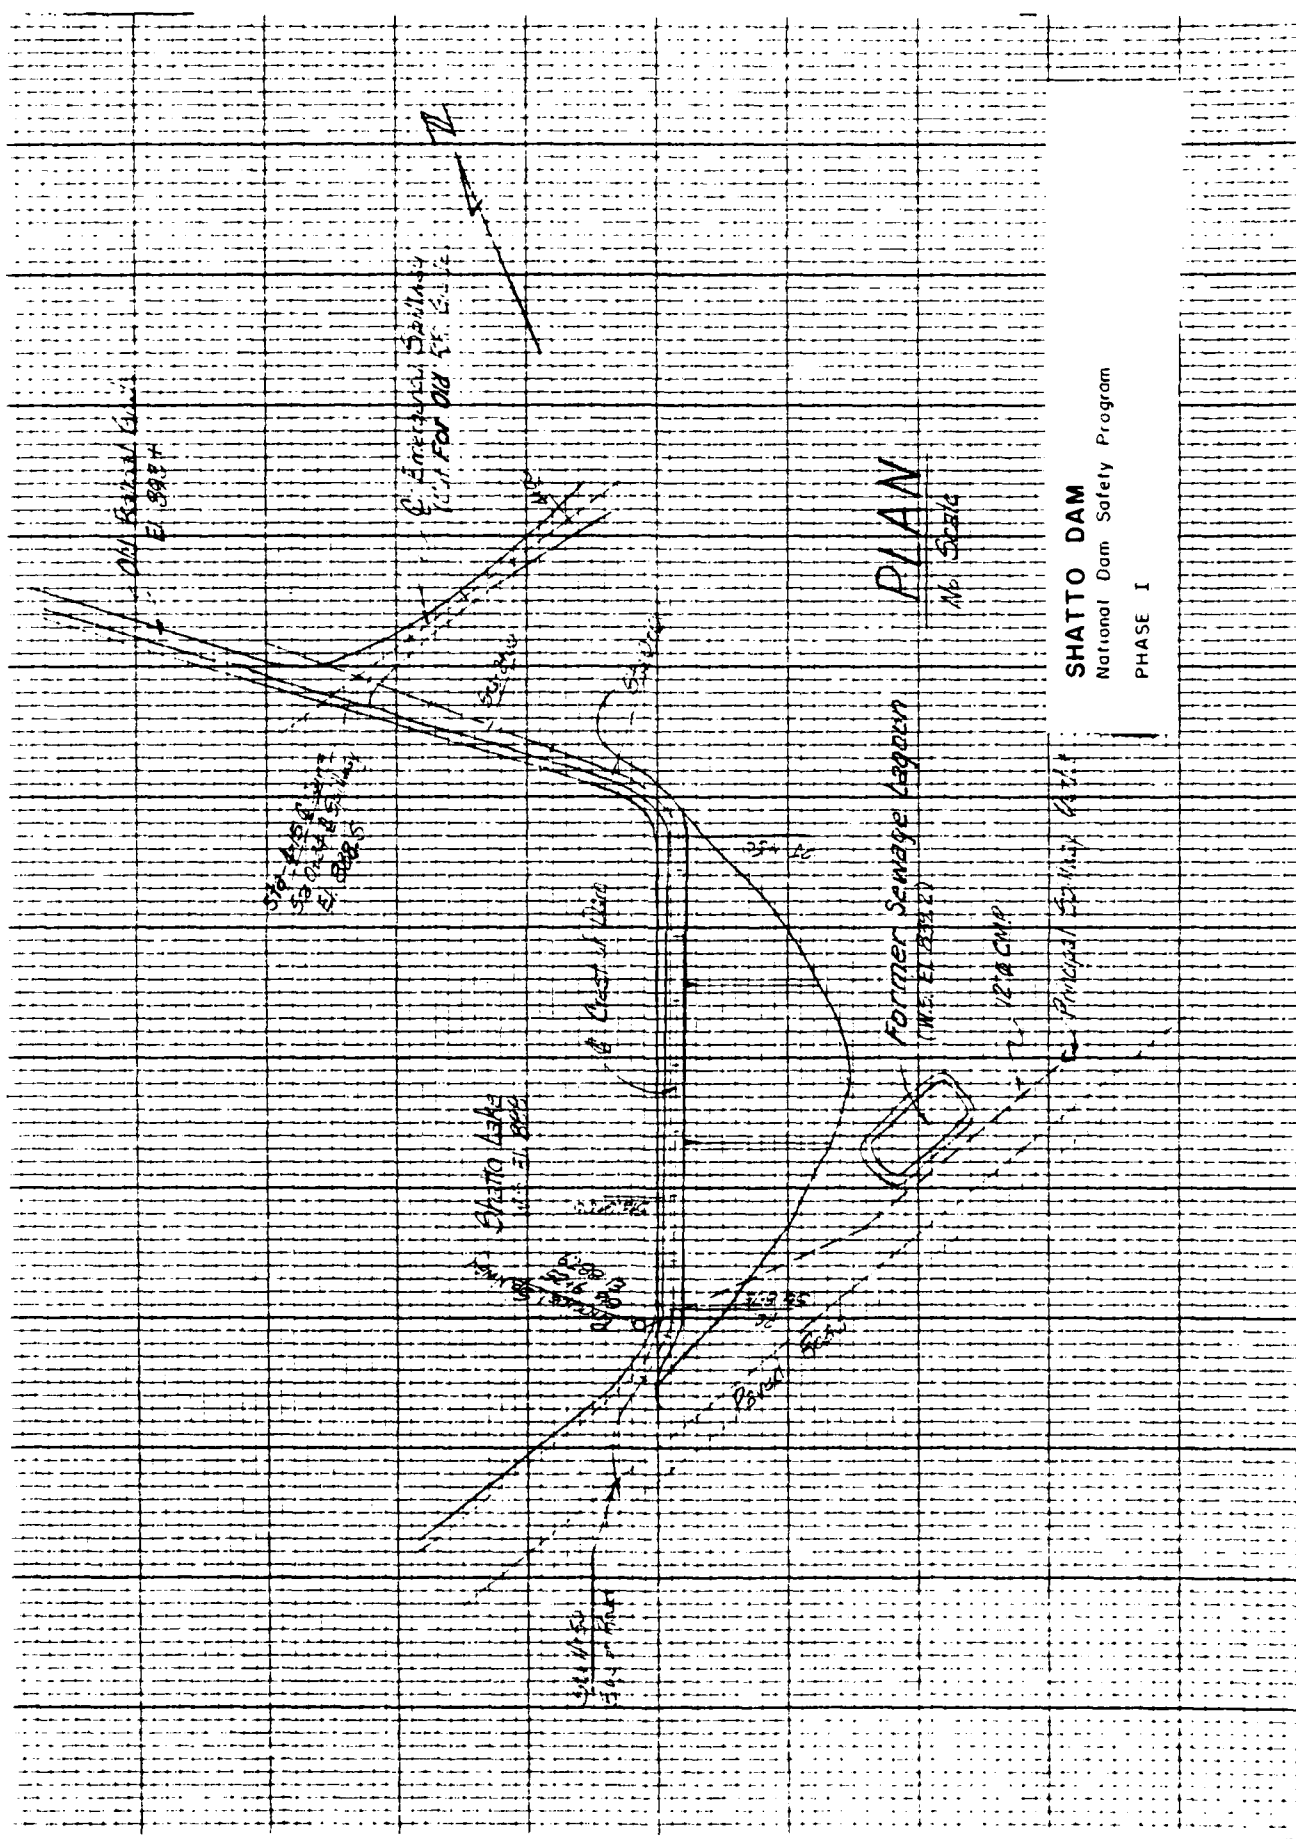
PLAN

Rough measurement along the crest of the dam (see Appendix C) showed little variance in crest elevation. Materials on the surface of the dam consist of lean to fat clays (CL or CH) with occasional gravel. No cracks or deformations were noted on the crest.
